The image shows the cover of a report titled "Public Rights-of-Way Access Advisory Committee Special Report: ACCESSIBLE PUBLIC RIGHTS-OF-WAY PLANNING and DESIGNING for ALTERATIONS". The cover features a technical diagram of a street intersection with several handwritten annotations in white. The annotations include: "ADD DETECTABLE WARNING" with an arrow pointing to a curb area; "add curbs" with an arrow pointing to a curb; "LONGER ACCESSIBLE TROTTLEWAY SIGNAL" with an arrow pointing to a signal area; "paint controller lean" with an arrow pointing to a curb area; and "Provides space for perpendicular routes and roundups" with an arrow pointing to a wide area. The number "2.08" is written in the bottom right of the diagram. A small circular logo in the bottom right corner of the cover says "July 2007".

The following slides contain information and graphics directly taken from the US Access Board's document entitled: Special Report: Accessible Public Rights-of-Way.

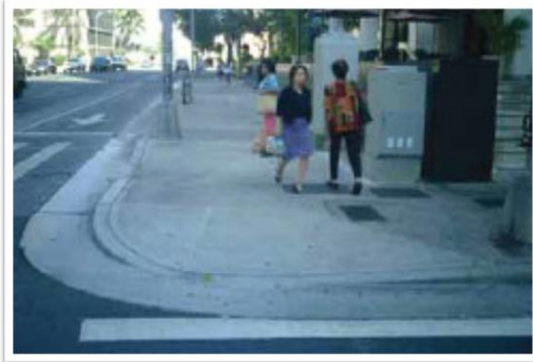
This urban corner is crowded with existing signal poles, signal boxes, and utility boxes that limit curb ramp design and placement. One solution, shown in the first photo is to reduce curb radius to maximize available corner area and ease flares to fit the available space. It is important to note that a detectable warning surface is still needed.

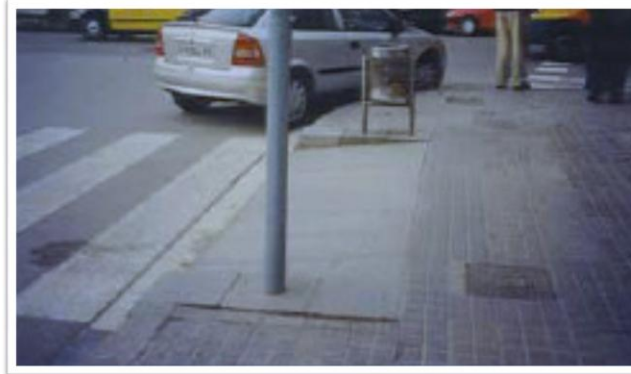
Another option, shown in lower photo is to shield ramp sides against pedestrian travel with pedestrian signal poles and sidewalk furnishings. By eliminating the flares, more corner area is gained. A benefit of using curb returns is that they offer useful way-finding cues for non-visual travel. Note that the curb ramp here is the full width of the crosswalk, another pedestrian benefit.

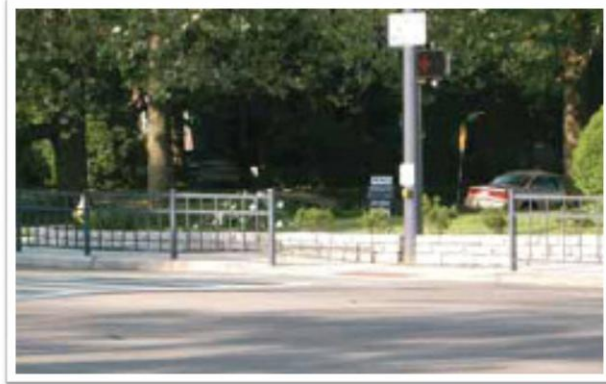
When this roadway was widened, only a 6-foot sidewalk remained. In this situation, a parallel, Type 2 curb ramp provides the most accessible design. The pedestrian signal is properly located at the back of the sidewalk, although APS have not been installed here. Also, this access route is used by children walking to school. A protective barrier was installed because of this and that the highway is a high-speed arterial.

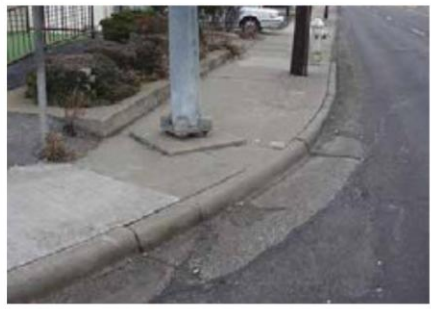
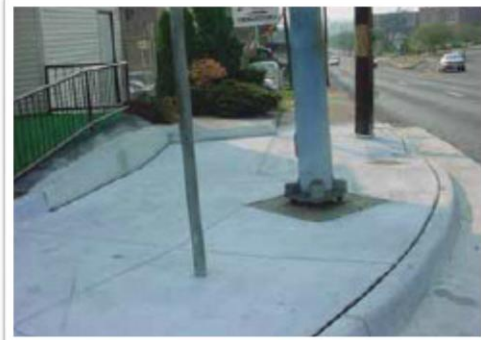
*Before*

*After*

In this case study involving narrow right-of-way, two curb ramps were installed in the very narrow sidewalks at this intersection by acquiring unused right-of-way from the adjacent property owner. A level landing for the curb ramps and a bypass route for pedestrians continuing around the corner was created without significant cost; the city engineer reported the ROW purchase at less than \$1,000. Additionally, detectable warning surfaces must be installed to fully comply with the latest standards.

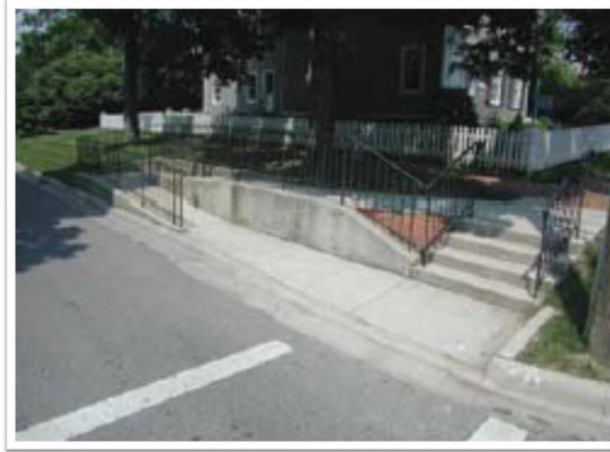
Sometimes difficult topography requires extraordinary solutions. In this photograph of an older residential neighborhood, the existing roadways are much lower than the sidewalks and separated by wide sloping lawns. New stairs and ramps—both with handrails—make the connection to the street crossing for pedestrians. Where technically feasible, the ramps should not exceed a 8.33% maximum slope.

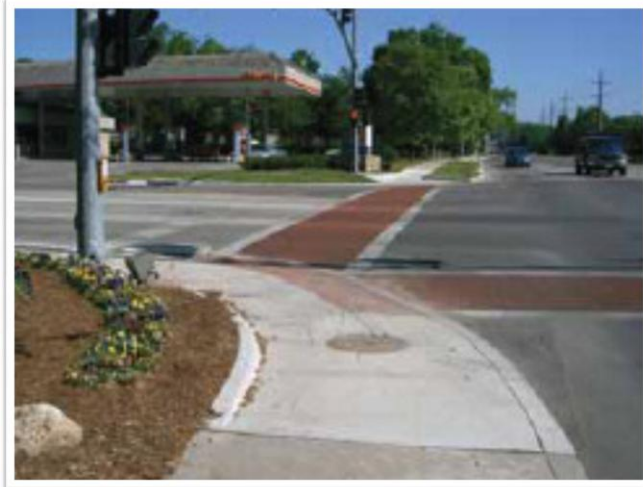
In suburban locations, like the one pictured, that have large corner radii, try installing blended transitions (running slopes that are less than 5.00%). Using brick unit detectable warning surfaces take a curve nicely and are easy to install. Also available are cast iron and masonry pavers that have radial domes. No matter which detectable warning surface is used, be sure that they meet the latest standards.
